**THE BOROUGH OF KENILWORTH**  
**UNION COUNTY**  
**NEW JERSEY**

**NJDPES MUNICIPAL STORMWATER REGULATION PROGRAM**  
**MS4 OUTFALL PIPE MAPPING**  
**ILLICIT CONNECTION ELIMINATION PROGRAM**  
**OUTFALL PIPE STREAM SCOURING REMEDIATION**

**May 23, 2007**

PMK Group #070247-09

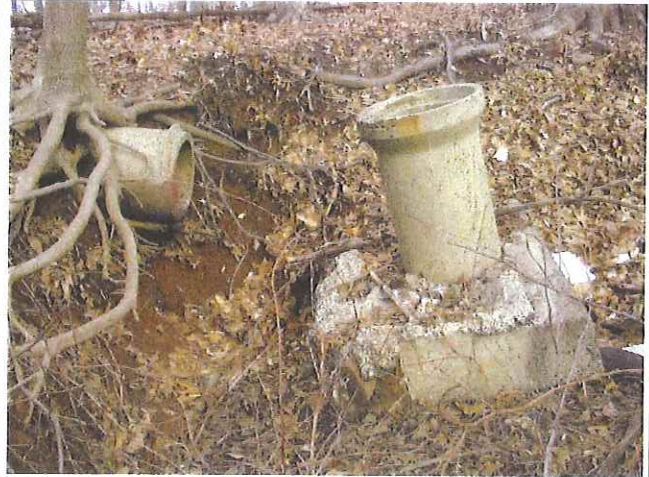
**Figure 1**

Outfall KB-01, located on Michigan Avenue, near the water tower, discharges into an unnamed ditch that flows into the West Branch, Elizabeth River. No dry-weather flow was observed during the inspection. The outfall structure has been compromised due to scouring and erosion present at the discharge point. Kenilworth should stabilize this area using methods found in the Standards for Soil Erosion and Sediment Control in New Jersey (N.J.A.C. 2:90-1). Prior to performing any repairs, the Borough should determine if any State, Federal or Local permits are required. The initial inspection of this outfall was conducted on March 26, 2007.

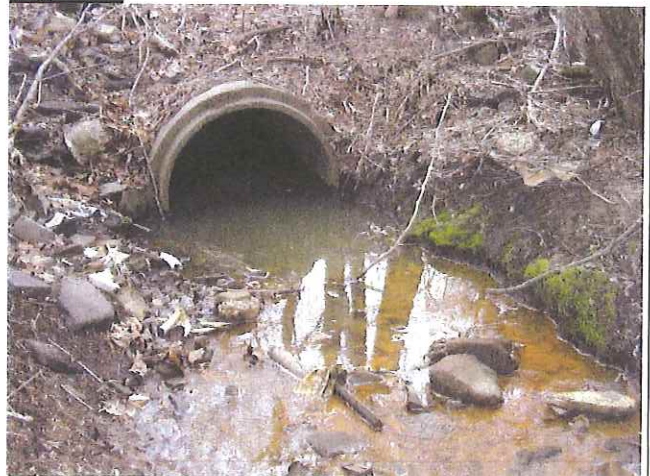
**Figure 2**

**Outfall KB-04**

Outfall KB-04, located near the Kenilworth PBA on Lafayette Place, discharges into the Old Channel. There was dry-weather flow observed discharging from the outfall at a rate of approximately ten (10) gallons per minute. Although this discharge appeared to be due to a piped stream, it appeared orange in color, which could be a sign of an illicit connection. At the time of the audit, a drilling operation was underway, upgradient, on the corner of Lafayette Place and Lafayette Ave which could have attributed to the orange color of the water. **As required by NJDEP, the Borough must investigate the source of this discharge and submit the Illicit Connection Inspection Report Form for this outfall with the Annual Report and Certification.** Scouring did not appear in the vicinity of the outfall and the outfall structure did not appear to be damaged at the time of our audit. The initial inspection of this outfall was conducted on March 26, 2007.

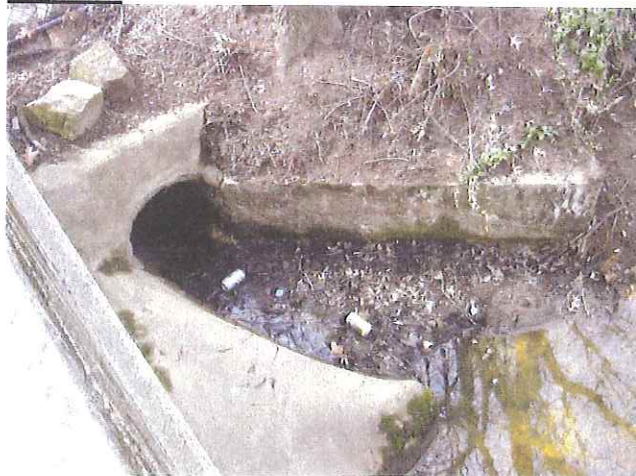
**Figure 3**

Outfall KB-06, located on Wilshire Drive, discharges into an unnamed tributary to the Rahway River. There was standing water present at the outfall location at the time of our audit. An up-gradient catch basin could not be located for inspection; however it appears that standing water is consistently present in this system due to backflow from the tributary. Water observed in this area was free of odor, color, and turbidity. Further investigation of this outfall is required to confirm the absence of an illicit connection. Scouring was not present in the vicinity of the outfall and the outfall structure did not appear to be damaged at the time of our audit. The initial inspection of this outfall was conducted on March 26, 2007.

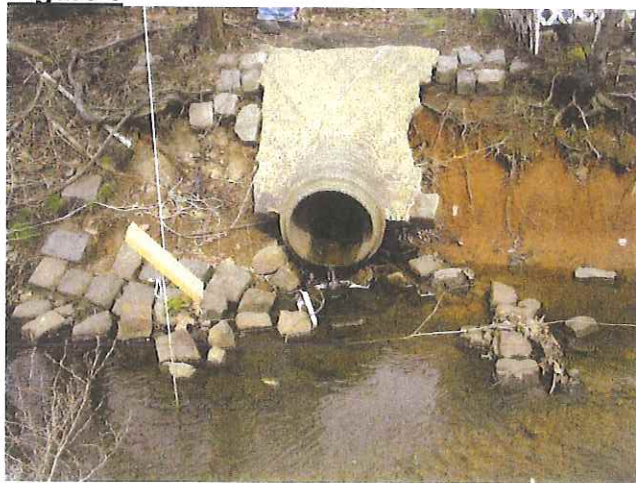
**Figure 5**

**Outfall KB-11**

Outfall KB-11, located in a drainage easement between Epping Drive and Pembroke Drive, discharges into an unnamed tributary to the Rahway River. Dry-weather flow was observed during the inspection at a rate of approximately five (five) gallons per minute (gpm). Water observed discharging from the outfall was free of odor, color, and turbidity. **As required by NJDEP, the Borough must investigate the source of this discharge and submit the Illicit Connection Inspection Report Form for this outfall with the Annual Report and Certification.** Scouring was present in the vicinity of the outfall at the time of the inspection and was affecting the stability of the outfall structure. Kenilworth should stabilize this area using methods found in the Standards for Soil Erosion and Sediment Control in New Jersey (N.J.A.C. 2:90-1). Damage to the headwall was also apparent. Prior to performing any repairs, the Borough should determine if any State, Federal or Local permits are required. The initial inspection of this outfall was conducted on March 26, 2007.

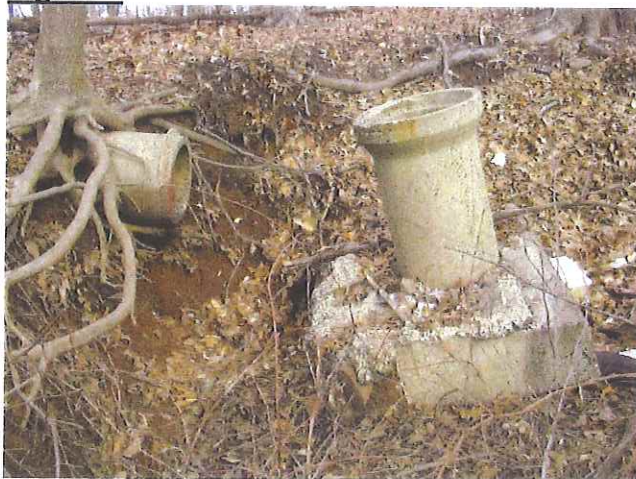
**Figure 1**

Outfall KB-01, located on Michigan Avenue, near the water tower, discharges into an unnamed ditch that flows into the West Branch, Elizabeth River. No dry-weather flow was observed during the inspection. The outfall structure has been compromised due to scouring and erosion present at the discharge point. Kenilworth should stabilize this area using methods found in the Standards for Soil Erosion and Sediment Control in New Jersey (N.J.A.C. 2:90-1). Prior to performing any repairs, the Borough should determine if any State, Federal or Local permits are required. The initial inspection of this outfall was conducted on March 26, 2007.

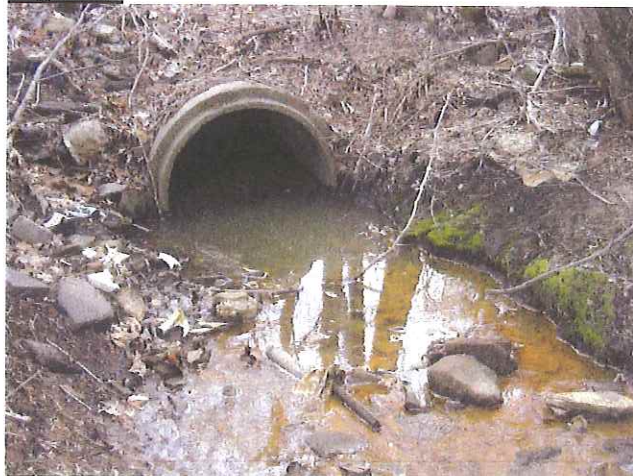
**Figure 2**

**Outfall KB-04**

Outfall KB-04, located near the Kenilworth PBA on Lafayette Place, discharges into the Old Channel. There was dry-weather flow observed discharging from the outfall at a rate of approximately ten (10) gallons per minute. Although this discharge appeared to be due to a piped stream, it appeared orange in color, which could be a sign of an illicit connection. At the time of the audit, a drilling operation was underway, upgradient, on the corner of Lafayette Place and Lafayette Ave which could have attributed to the orange color of the water. **As required by NJDEP, the Borough must investigate the source of this discharge and submit the Illicit Connection Inspection Report Form for this outfall with the Annual Report and Certification.** Scouring did not appear in the vicinity of the outfall and the outfall structure did not appear to be damaged at the time of our audit. The initial inspection of this outfall was conducted on March 26, 2007.

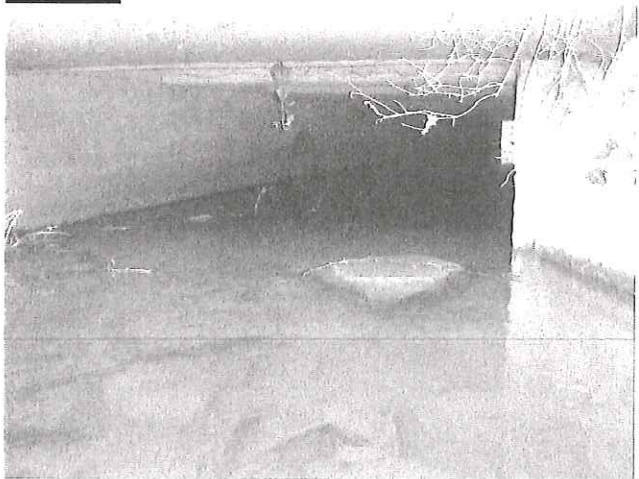
#### **Figure 8**

Outfall KB-22a, located under the Faitoute Avenue bridge, near Cranford Avenue, discharges into an unnamed tributary to the Rahway River. There was standing water present at the outfall location at the time of our audit; therefore, the dry-weather flow inspection was conducted at an upgradient inlet. There were no indications of dry-weather flow in the inlet. It appears that standing water is consistently present in the vicinity of the outfall due to backflow from the tributary. Scouring was not present in the vicinity of the outfall and the outfall structure did not appear to be damaged at the time of our audit. The initial inspection of this outfall was conducted on March 26, 2007.

**Outfall KB-22a** is on the far corner of the left wall (north corner of bridge). **Outfall KB-22c** is on the near corner of the left wall (west corner of bridge). **Outfall KB-22b** (opposite 22a) and **Outfall KB-22d** (opposite 22c) are not visible.

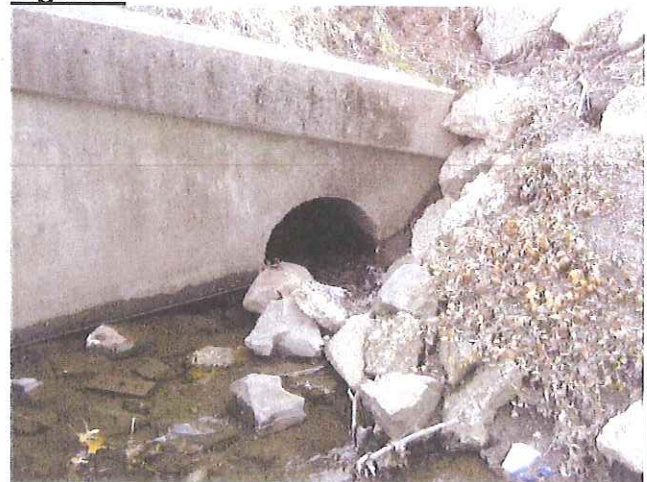
**Figure 9**

Outfall KB-23, located at Bloomingdale Avenue and Trenton Avenue, discharges into the south side of an unnamed tributary to the Rahway River. There was standing water present at the outfall location at the time of our audit; therefore, the dry-weather flow inspection was conducted at an upgradient inlet. There were no indications of dry-weather flow in the inlet. It appears that standing water is consistently present in this outfall due to backflow from the tributary. Scouring was not present in the vicinity of the outfall and the outfall structure did not appear to be damaged; however a significant amount of sediment and rocks have accumulated outside the outfall pipe. The Borough should maintain this structure to ensure it is functioning properly. The initial inspection of this outfall was conducted on March 26, 2007.

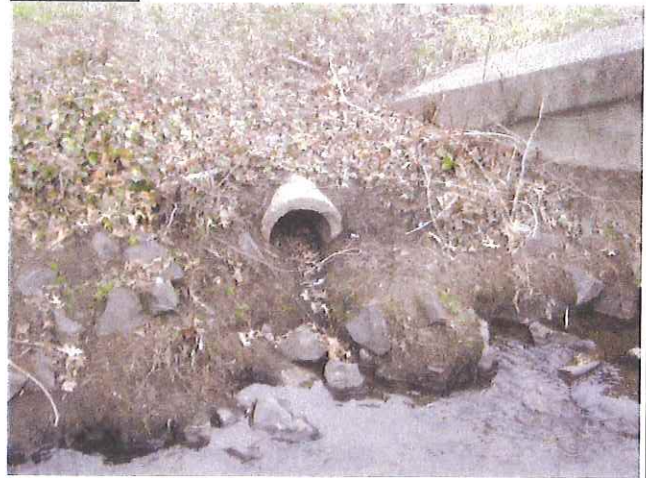
**Figure 10**

Outfall KB-24, located at Bloomingdale Avenue and Trenton Avenue, discharges into the north side of an unnamed tributary to the Rahway River. No dry-weather flow was observed during the inspection. Scouring was not present in the vicinity of the outfall and the outfall structure did not appear to be damaged at the time of our audit; however a significant amount of sediment and rocks have accumulated outside the outfall pipe. The Borough should maintain this structure to ensure it is functioning properly. The initial inspection of this outfall was conducted on March 26, 2007.

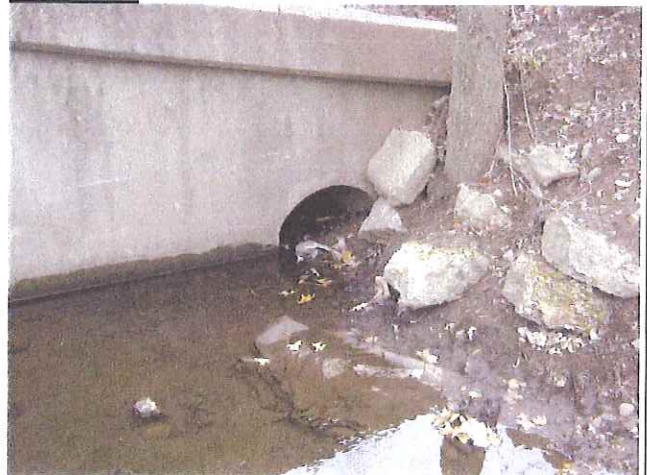
**Figure 11**

Outfall KB-25, located on the west side of Michigan Avenue and Trenton Avenue, discharges into the south side of an unnamed tributary to the Rahway River. There was standing water present at the outfall location at the time of our audit; therefore, the dry-weather flow inspection was conducted at an upgradient inlet. There were no indications of dry-weather flow in the upgradient inlet. It appears that standing water is consistently present in this outfall due to backflow from the tributary. Scouring was not present in the vicinity of the outfall and the outfall structure did not appear to be damaged; however a significant amount of sediment and rocks have accumulated outside the outfall pipe. The Borough should maintain this structure to ensure it is functioning properly. The initial inspection of this outfall was conducted on March 26, 2007.

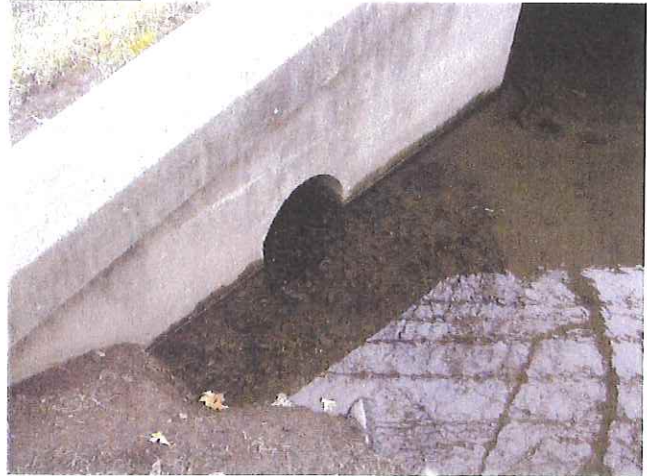
**Figure 12**

Outfall KB-26, located on the west side of Michigan Avenue and Trenton Avenue, discharges into the north side of an unnamed tributary to the Rahway River. There was standing water present at the outfall location at the time of our audit; therefore, the dry-weather flow inspection was conducted at an upgradient inlet. There were no indications of dry-weather flow in the inlet. It appears that standing water is consistently present in this outfall due to backflow from the tributary. Scouring was not present in the vicinity of the outfall and the outfall structure did not appear to be damaged at the time of our audit. The initial inspection of this outfall was conducted on March 26, 2007.

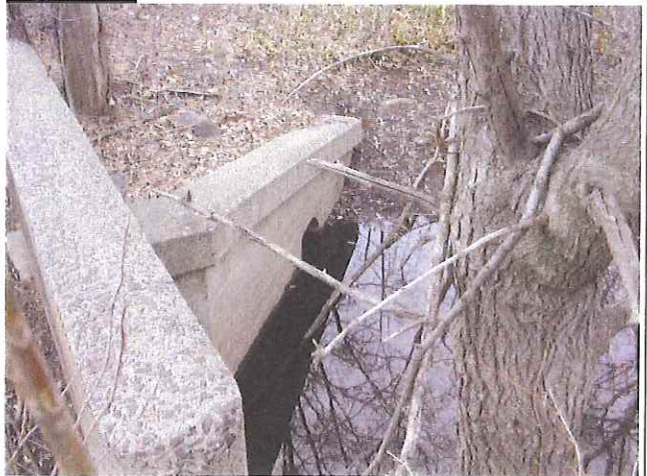
**Figure 13**

Outfall KB-27, located behind a fence on the east side of Michigan Avenue at Trenton Avenue, discharges into the north side of an unnamed tributary to the Rahway River. There was standing water present at the outfall location at the time of our audit; therefore, the dry-weather flow inspection was conducted at an upgradient inlet. There were no indications of dry-weather flow in the inlet. It appears that standing water is consistently present in this outfall due to backflow from the tributary. Scouring was not present in the vicinity of the outfall and the outfall structure did not appear to be damaged at the time of our audit. The initial inspection of this outfall was conducted on March 26, 2007.

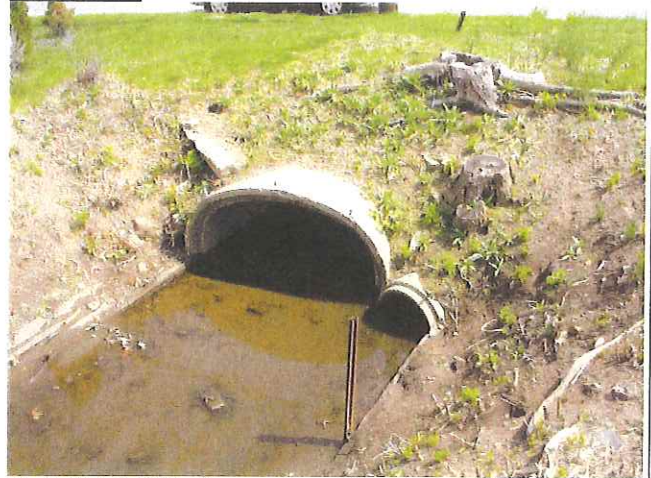
**Figure 14**

Outfall KB-29, located on South 31<sup>st</sup> Street (south of the Garden State Parkway), discharges into the south side of an unnamed tributary to the Rahway River. There was standing water present at the outfall location at the time of our audit; therefore, the dry-weather flow inspection was conducted at an upgradient inlet. There was standing water in the upgradient inlet; therefore the inspection could not be completed. Further investigation of this outfall is required to confirm the absence of an illicit connection. Scouring was not present in the vicinity of the outfall and the outfall structure did not appear to be damaged at the time of our audit. The initial inspection of this outfall was conducted on April 24, 2007.

*Outfall KB-29 is the smaller of the pipes. The larger pipe is a piped stream from a private retention pond.*

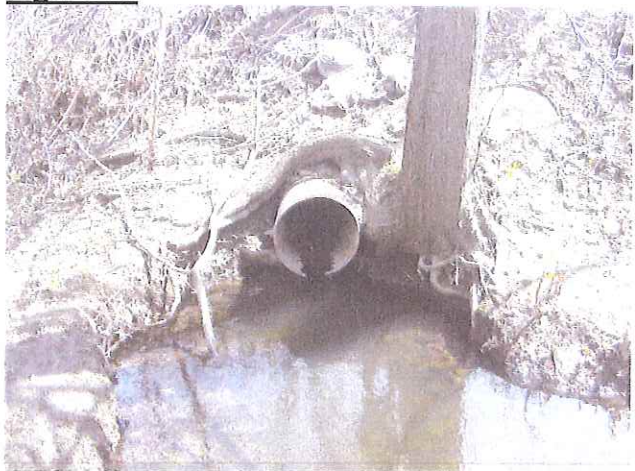
**Figure 15**

Outfall KB-30, located at the bend in Hoiles Drive, discharges to Morses Creek. No dry-weather flow was observed during the inspection; however, there was evidence of intermittent flow. Although water was not discharging at the time of the audit, the bottom of the pipe has deteriorated which may indicate an illicit connection to the storm sewer system. As required by NJDEP, the Borough must make three (3) additional inspections in an attempt to identify dry-weather flow from this structure. If these attempts are unsuccessful, Kenilworth must submit a Closeout Investigation Form with the Annual Report. Additionally, scouring was present in the vicinity of the outfall at the time of the audit. All repairs should be made using methods found in the Standards for Soil Erosion and Sediment Control in New Jersey (N.J.A.C. 2:90-1). Prior to performing any repairs, the Borough should determine if any State, Federal or Local permits are required. The initial inspection of this outfall was conducted on April 24, 2007.

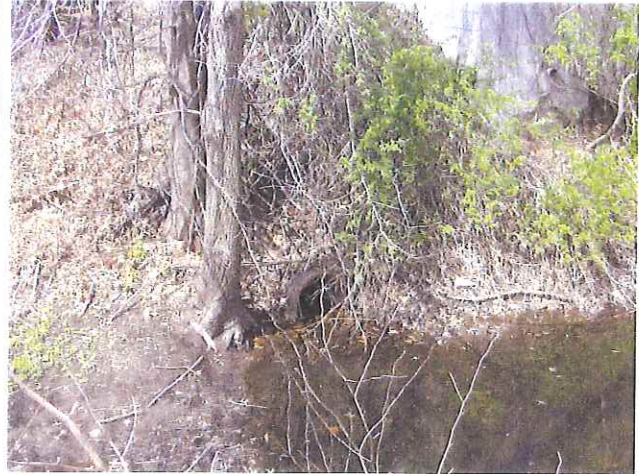
**Figure 16**

Outfall KB-31, located on Hoiles Drive, discharges to the west side of Morses Creek. There was standing water present at the outfall location at the time of our audit. An up-gradient catch basin could not be located for inspection; however it appears that standing water is consistently present in this system due to backflow from the creek. Water observed in this area was free of odor, color, and turbidity. Further investigation of this outfall is required to confirm the absence of an illicit connection. Scouring was not present in the vicinity of the outfall and the outfall structure did not appear to be damaged at the time of our audit. The initial inspection of this outfall was conducted on April 24, 2007.

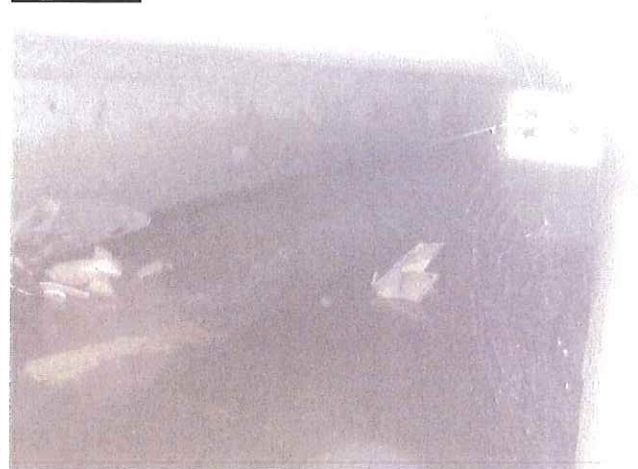
**Figure 17**

Outfall KB-32, located under the southeast corner of the Market Street bridge, discharges to Morses Creek. There was standing water present at the outfall location at the time of our audit; therefore, the dry-weather flow inspection was conducted at an upgradient inlet. There were no indications of dry-weather flow in the inlet. It appears that standing water is consistently present in this outfall due to backflow from the creek. Scouring was not present in the vicinity of the outfall and the outfall structure did not appear to be damaged at the time of our audit. The initial inspection of this outfall was conducted on April 24, 2007.

*Outfall KB-32 is at the far (upstream) end of this bridge culvert.*

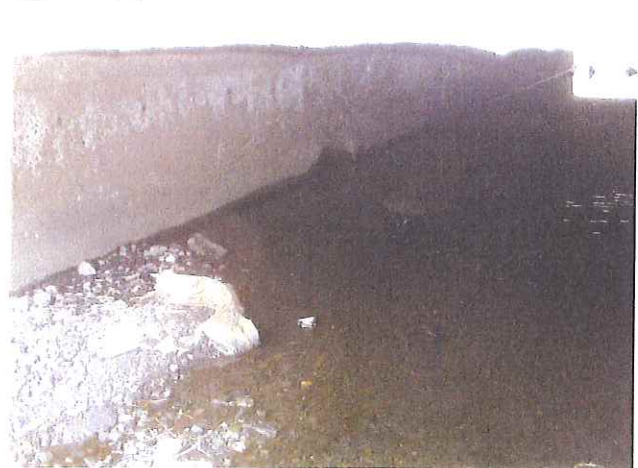
**Figure 18**

Outfall KB-33, located under the northwest corner of the Market Street bridge, discharges to Morses Creek. There was standing water present at the outfall location at the time of our audit; therefore, the dry-weather flow inspection was conducted at an upgradient inlet. There were no indications of dry-weather flow in the inlet. It appears that standing water is consistently present in this outfall due to backflow from the creek. Scouring was not present in the vicinity of the outfall and the outfall structure did not appear to be damaged at the time of our audit. The initial inspection of this outfall was conducted on April 24, 2007.

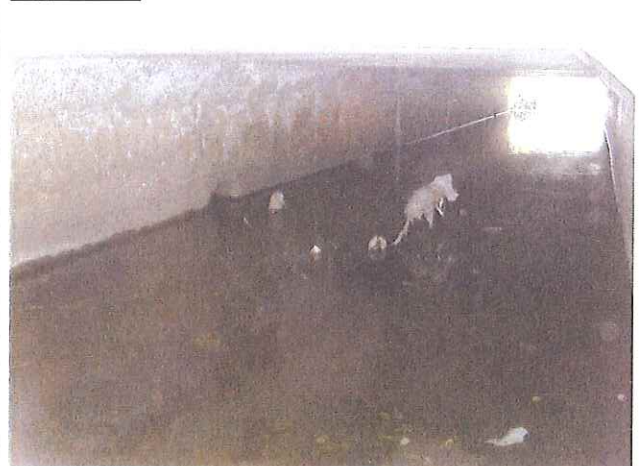
**Figure 19**

Outfall KB-34, located under the southeast corner of the Carnegie Avenue bridge, discharges to Morses Creek. There was standing water present at the outfall at the time of our audit; therefore, the dry-weather flow inspection was conducted at an upgradient inlet. There was standing water in the upgradient inlet, so the inspection could not be completed. It appears that standing water is consistently present in this outfall due to backflow from the creek; however, further investigation of this outfall is required to confirm the absence of an illicit connection. Scouring was not present in the vicinity of the outfall and the outfall structure did not appear to be damaged at the time of our audit. The initial inspection of this outfall was conducted on April 24, 2007.

*Outfall KB-34 is on the near left side of bridge culvert.  
Outfall KB-35 is on the far left corner of bridge culvert.*

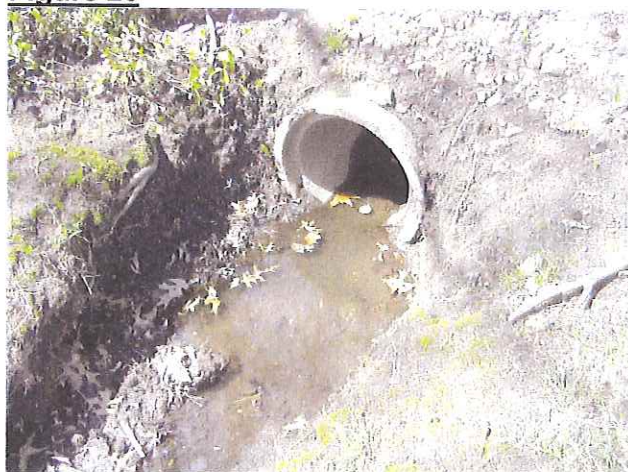
**Figure 20**

Outfall KB-36, located on Lexington Ave., discharges to Morses Creek. There was standing water present at the outfall location at the time of our audit. An up-gradient catch basin could not be located for inspection; however it appears that standing water is consistently present in this outfall due to poor drainage caused by scouring. Water observed in this area was free of odor, color, and turbidity. Further investigation of this outfall is required to confirm the absence of an illicit connection. All repairs should be made using methods found in the Standards for Soil Erosion and Sediment Control in New Jersey (N.J.A.C. 2:90-1). Prior to performing any repairs, the Borough should determine if any State, Federal or Local permits are required. The initial inspection of this outfall was conducted on April 24, 2007.

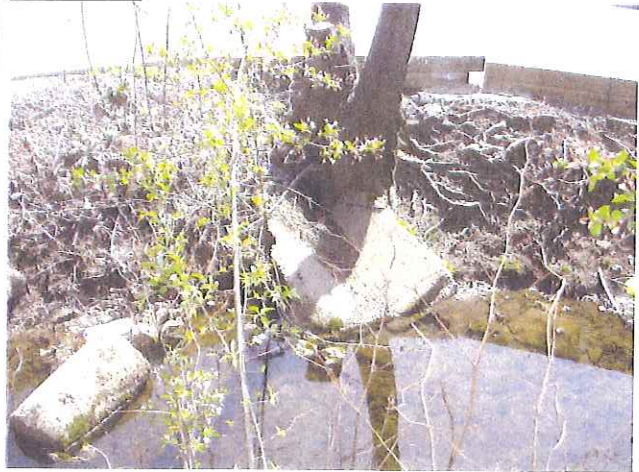
**Figure 21**

Outfall KB-37, behind the Feedland parking lot, is set back from the corner of Carnegie Avenue and Lexington Avenue. and discharges to Morses Creek. Although water was not discharging at the time of the audit, the pipe and spillway were wet more than six (6) days after a rain event, which may indicate an illicit connection to the storm sewer system. As required by NJDEP, the Borough must make three (3) additional inspections in an attempt to identify dry-weather flow from this structure. If these attempts are unsuccessful, Kenilworth must submit a Closeout Investigation Form with the Annual Report. Scouring was not present in the vicinity of the outfall; however, a tree has grown into the structure. The Town should ensure that this damage does not affect the integrity of the outfall structure. Any repairs should be made in accordance with the Standards for Soil Erosion and Sediment Control in New Jersey (N.J.A.C. 2:90-1). Prior to performing any repairs, the Borough should determine if any State, Federal or Local permits are required. The initial inspection of this outfall was conducted on April 24, 2007.

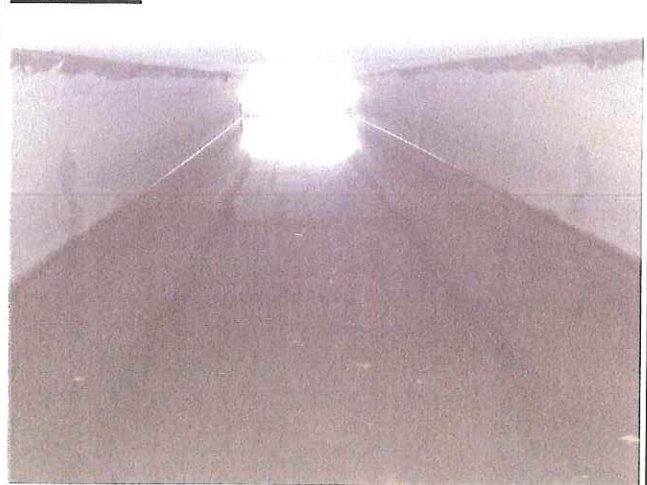
**Figure 22**

Outfalls KB-38, KB-39, KB-40 and KB-41 are located under the Michigan Avenue. bridge near Lexington Avenue. and discharge to Morses Creek. There was standing water present at KB-38 and KB-39; therefore, upgradient inlets were inspected for signs of dry-weather flow. There were no indications of dry-weather flow at either inlet. It appears that standing water is consistently present in the vicinity of these outfalls due to backflow from the creek. There was no dry-weather flow observed at KB-40 or KB-41. Scouring was not present in the vicinity of the outfalls and the outfall structures did not appear to be damaged at the time of our audit. The initial inspection of these outfalls was conducted on April 24, 2007.

Outfall KB-38 is on the far left, northeast corner of bridge culvert; Outfall KB-39 (distant right; southeast corner of bridge culvert; Outfall KB-40 is on the near left; north west corner of bridge culvert; Outfall KB-41 is on the near right; southwest corner of bridge culvert

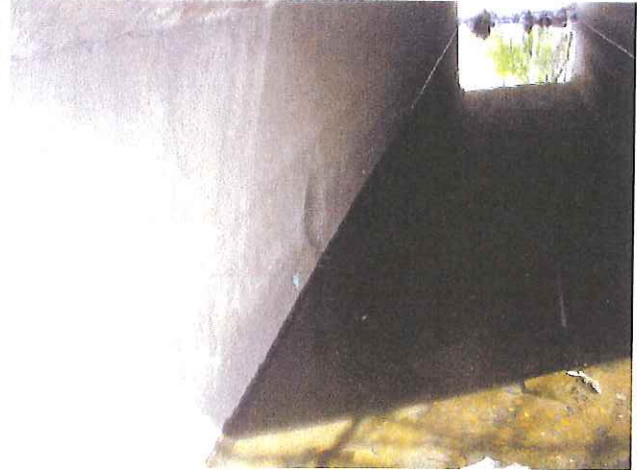
**Figure 23**

Outfall KB-42, located under the northern side of the Faitoute Avenue bridge, near Michigan Ave, discharges to Morses Creek. No dry-weather flow was observed and scouring was not present in the vicinity of the outfall at the time of the audit. The outfall structure did not appear to be damaged at the time of our audit. The initial inspection of this outfall was conducted on April 24, 2007.

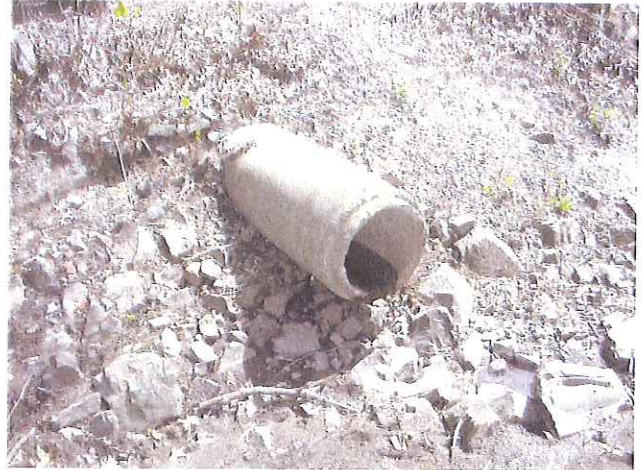
**Figure 25**

Outfall KB-44, located at the end of Maplewood Avenue, discharges to Morses Creek. Although water was not discharging at the time of the audit, the pipe was wet more than six (6) days after a rain event, which may indicate an illicit connection to the storm sewer system. As required by NJDEP, the Borough must make three (3) additional inspections in an attempt to identify dry-weather flow from this structure. If these attempts are unsuccessful, Kenilworth must submit a Closeout Investigation Form with the Annual Report. Scouring was not present in the vicinity of the outfall and the outfall structure did not appear to be damaged at the time of our audit. The initial inspection of this outfall was conducted on April 24, 2007.

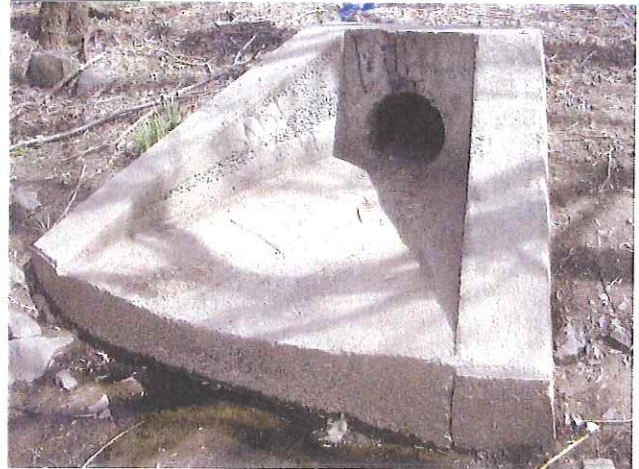
**Figure 26**

Outfall KB-45, located at the end of Oakwood Avenue, discharges to Morses Creek. No dry-weather flow was observed and scouring was not present in the vicinity of the outfall at the time of the audit. The outfall structure did not appear to be damaged at the time of our audit. The initial inspection of this outfall was conducted on April 24, 2007.

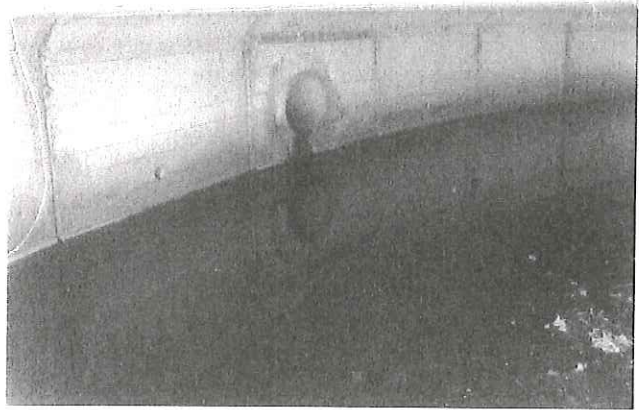
**Figure 27**

\*\*\* It appears that the water level is variable and should be considered when investigating this outfall.
